GLOBAL Rotax MAX Challenge Technical Regulation 2022

Bulletin no.: 02

Valid as of: 2022 03 16

Addendum/changes (highlighted in yellow) to Global RMC Technical Regulation 2022, Edition 2021 10 12

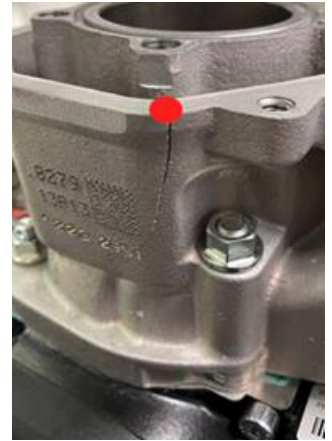
Example 1, Damaged Cylinder due to freezing.

It is allowed to repair the cracked cylinder by welding.
It would also be allowed to dress / finish the area marked red to restore the part to the original specification.

It would not be allowed to dress / finish areas not effected by damage.
