GLOBAL Rotax MAX Challenge Technical Regulation 2022

Bulletin no.: 02

Valid as of: 2022 03 16

Addendum/changes (highlighted in yellow) to Global RMC Technical Regulation 2022, Edition 2021 10 12

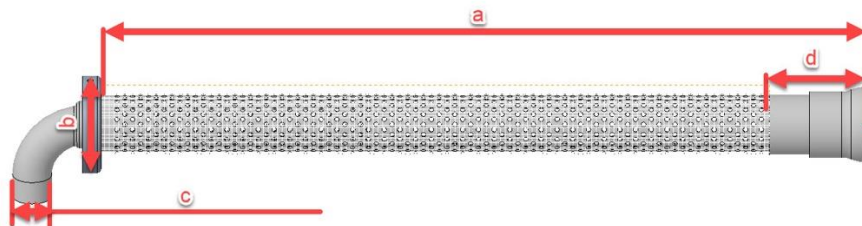
The measurements in the diagram below are as follows:

- (a) at least 484 mm note: measurement removed until further notice
- (b) minimum outside diameter of 61 mm
- (c) maximum outside diameter of 26 mm
- (d) at least 63 mm
